Intel[®] Pentium[®] III Processor Specification Update

Release Date: August 2001

Order Number: 244453-033

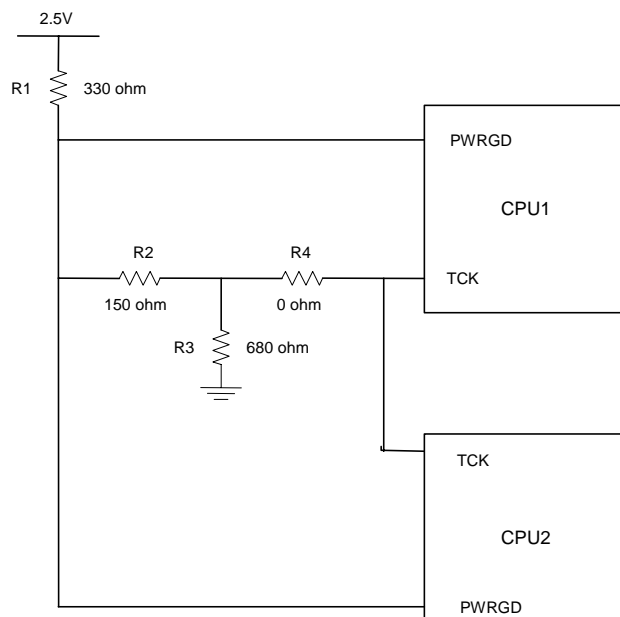
Pentium® III Processor with 512KB L2 Cache Platforms Workaround

In addition, the example workaround circuits shown do not support production motherboard test methodologies that require the use of the processor JTAG/TAP port. Alternative workaround solutions must be found if such test capability is required.

Assumes the inputs to the CPU_PWRGD are open collector signals that are Wire-ANDed together

- The example workaround circuit assumes that the PWRGD inputs into the processors are open collector. Tying the PWRGD inputs together in a Wired-AND fashion allows each processor to receive PWRGD at the same time but at the latter of the 2 separate PWRGD assertions. If separation of the PWRGD inputs to each processor is required, extra circuitry will be required.
